Compliance Evaluation Inspection Report

**P4 Production, LLC./Blackfoot Bridge Mine
(a subsidiary of the Monsanto Company.)
Soda Springs, Idaho**

NPDES Permit Tracking # IDR05CR88

**Inspection date: September 23, 2014
Report completion date: December 1, 2014**

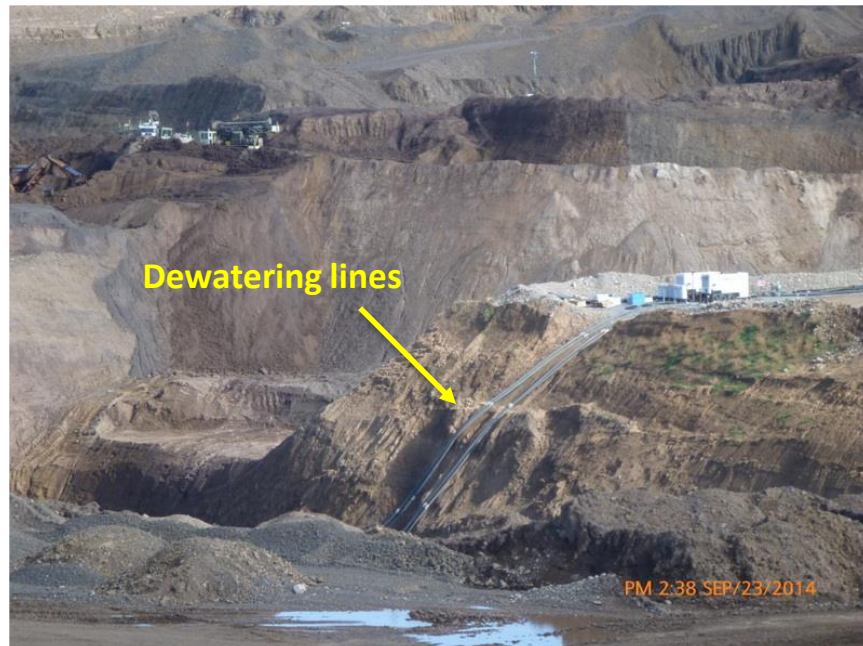
Photo No. 7 (P1000708)
Facing east across North Pit – the dewatering lines from bottom of Phase 1;
equipment in background/upper left is staged at south end of Phase 3.

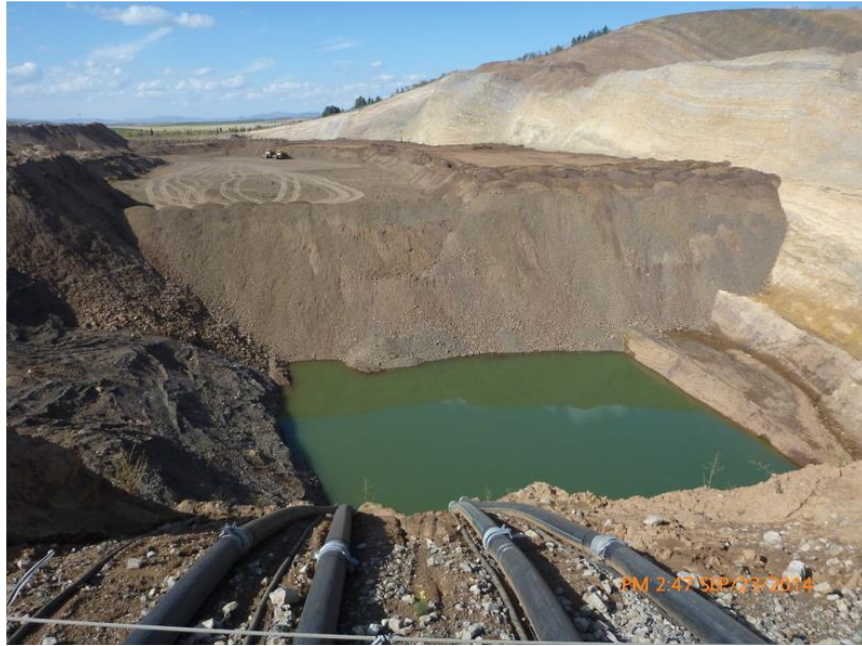
Photo No. 9 (P1000725)
Facing north – View into Phase 1 of North Pit. This phase has been mined out and backfilled except for a small basin used for dewatering at south end of Phase 1. .

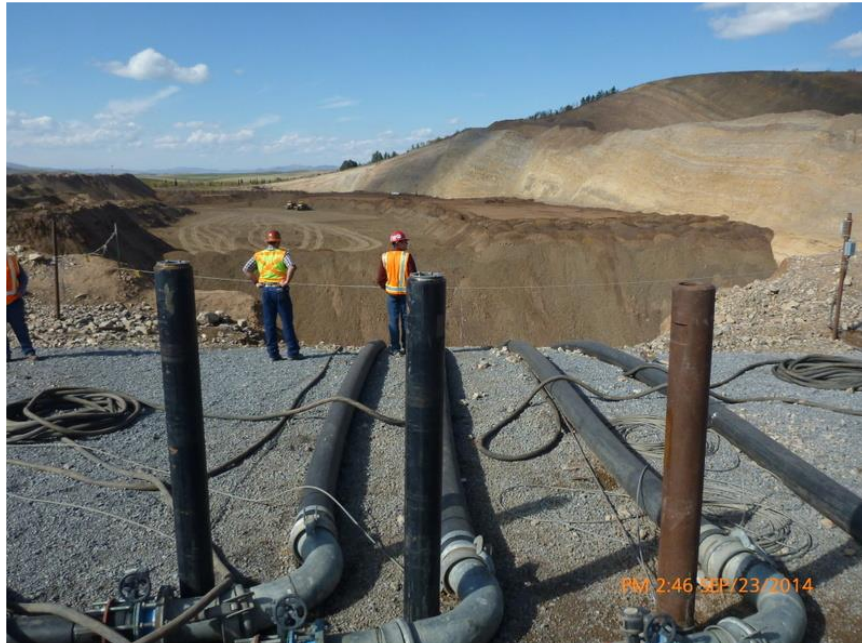
Photo No. 10 (P1000723)
Facing north – these are the 4-6" HDPE pipes used to pump groundwater from the Phase 1 groundwater basin to the North Tipple Pond.

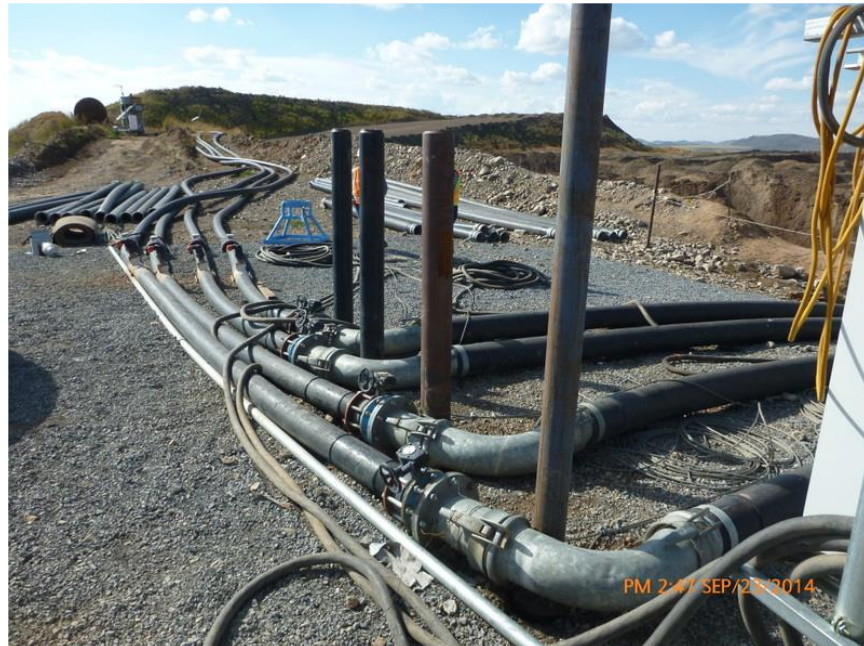
Photo No. 11 (P1000724)
Facing west – the dewatering lines from Phase 1 to the North Tipple Pond.

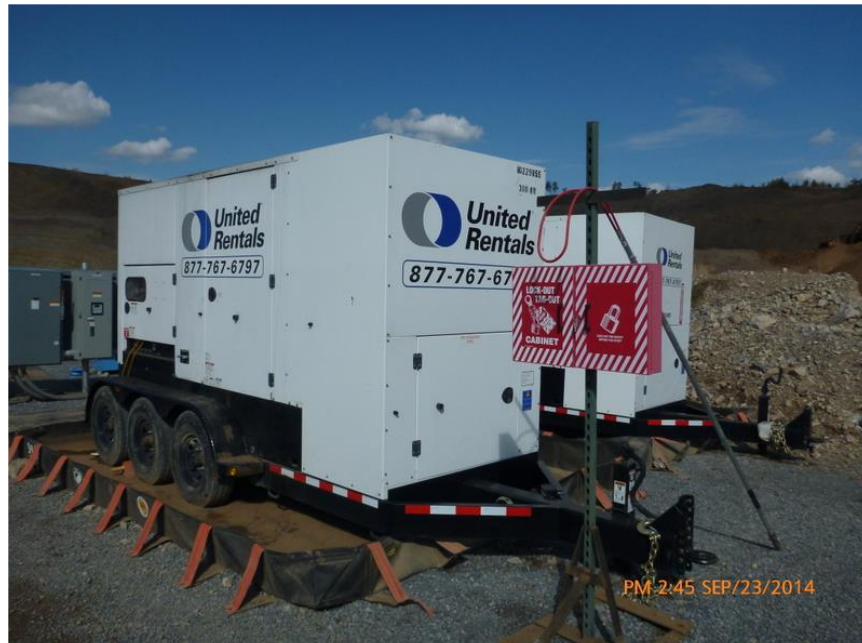
Photo No. 12 (P1000722)
Facing northeast –the generators for the dewatering pumps.

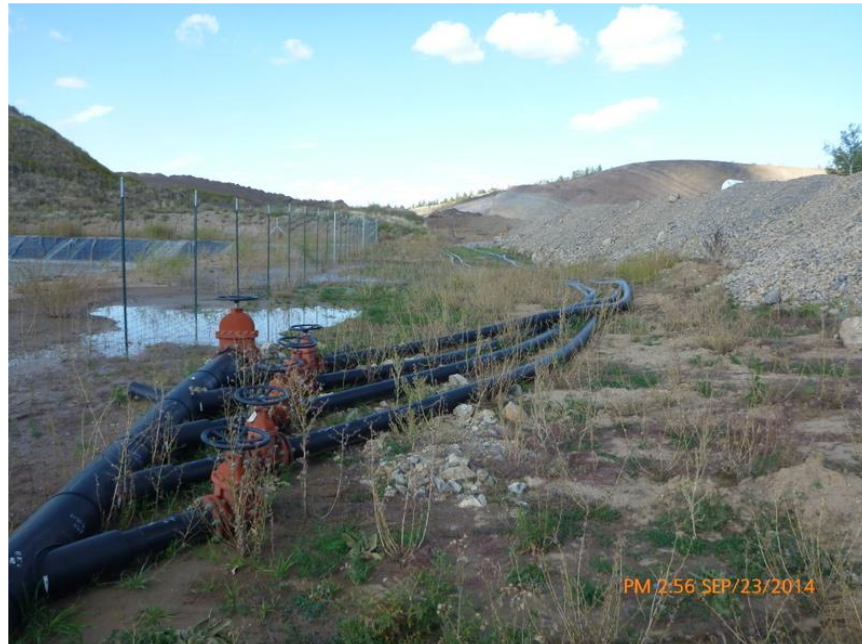
Photo No. 15 (P1000727)
Facing north – the 4-6" HDPE lines from the pit dewatering operation come together at this manifold prior to discharge to the North Tipple Pond. .

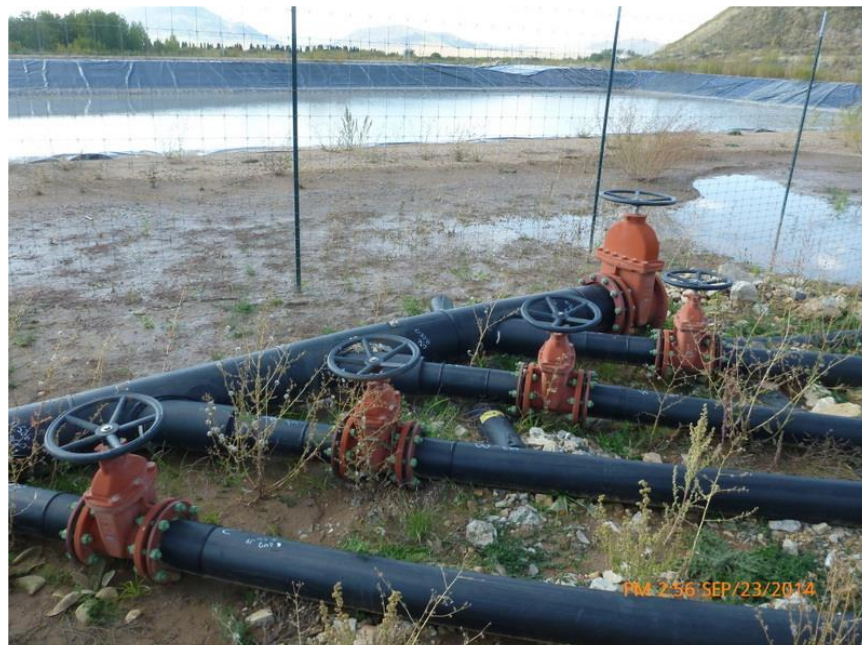
Photo No. 16 (P1000728)
Facing northwest – the North Pit dewatering manifold with North Tipple Pond in the background; water discharges to the pond.

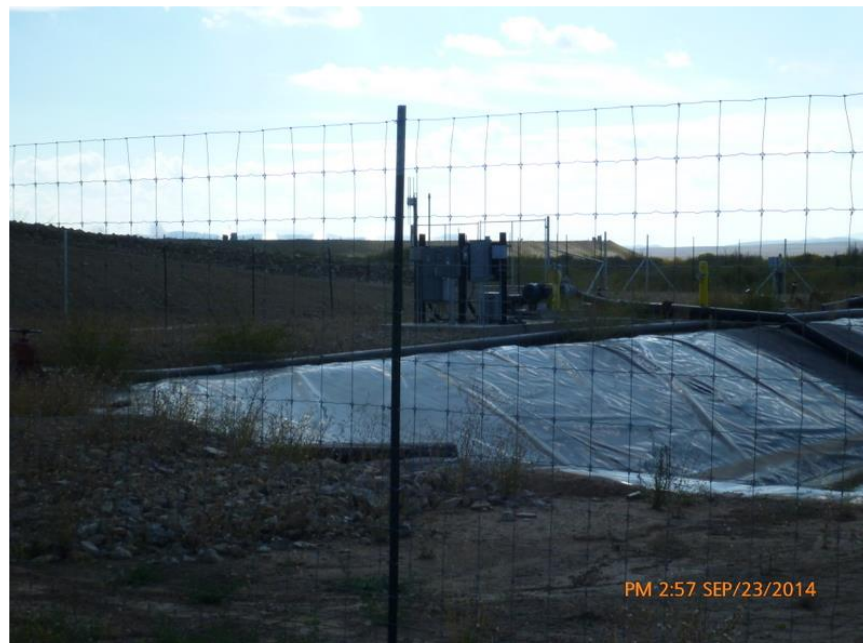
Photo No. 18 (P1000729)
Facing southwest– pump and intake line from North Tipple Pond; delivers water to CP2.

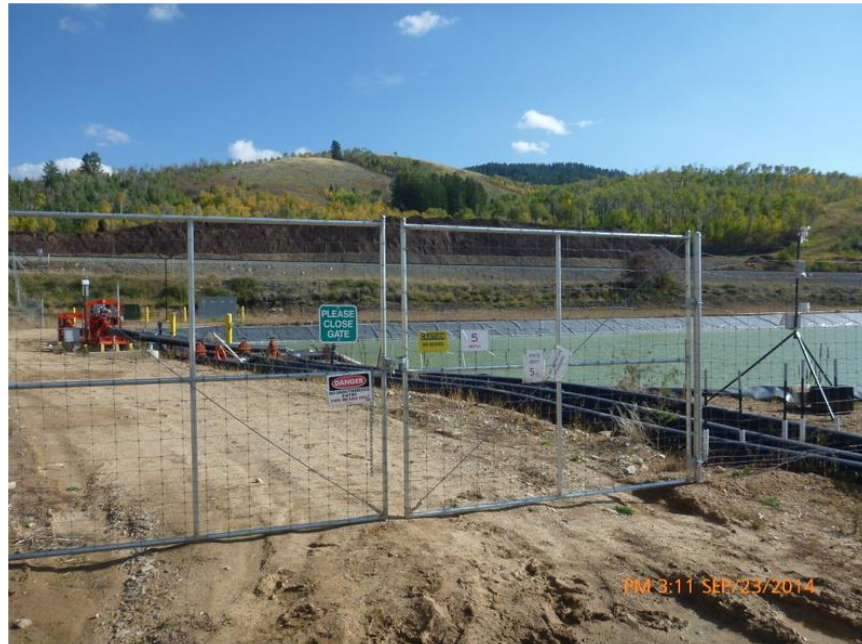
Photo No. 19 (P1000737)

Facing southwest – CP2 receives water from North Tipple Pond and other locations around the site that are known or expected to exceed Idaho Water Quality Standards (IWQs).

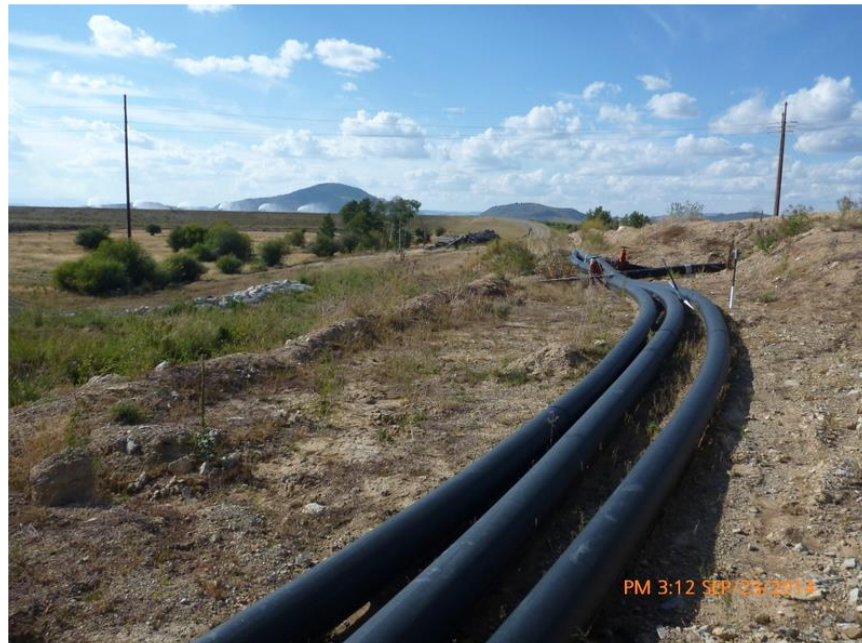
Photo No. 20 (P1000738)

Facing northeast – these 3 HDPE lines are used to pump water from CP2 to Water Management Pond 1 or 2.

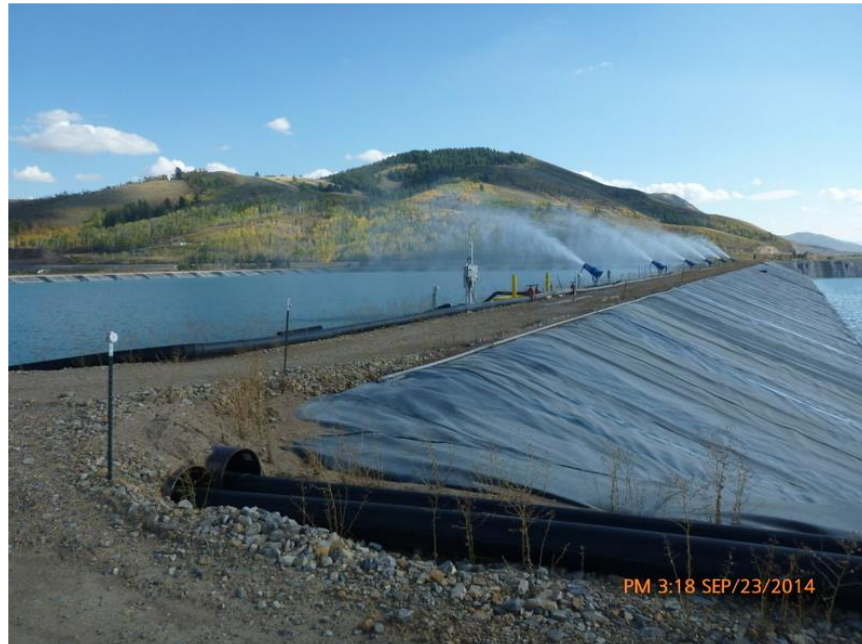
Photo No. 21 (P1000739)

Facing southeast – evaporator canons (“Landsharks”) are located along the west side of each of the water management ponds. The evaporators will not function when the wind direction is likely to cause off-site drift. Water balance could be a potential issue under certain conditions.

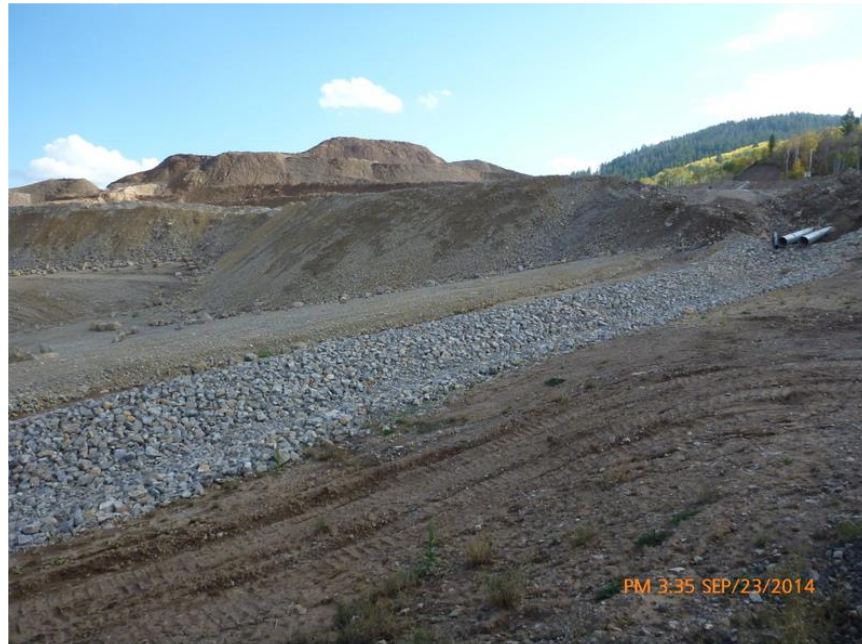
Photo No. 23 (P1000745)

Facing southwest – this is the upper portion of the rock-lined channel that was built to convey stormwater and snowmelt from the area above the Mid Pit/East Overburden Pile (EOP) haul road to the East Pond (EP) 1. The structure did not appear on the SWPPP site map at the time of this inspection.

Mr. Stoll noted that a BMP observed in the field (rock-lined channel from Mid-Seg Road to EP-1) was not on the stormwater map.

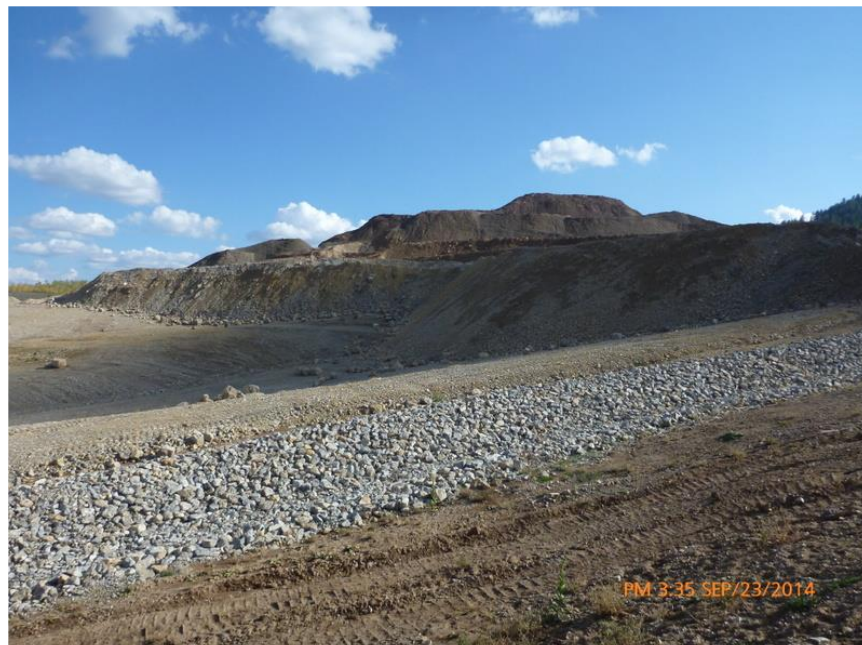
Photo No. 24 (P1000742)

Facing southeast – another view of the haul road stormwater channel with the EOP in the background.

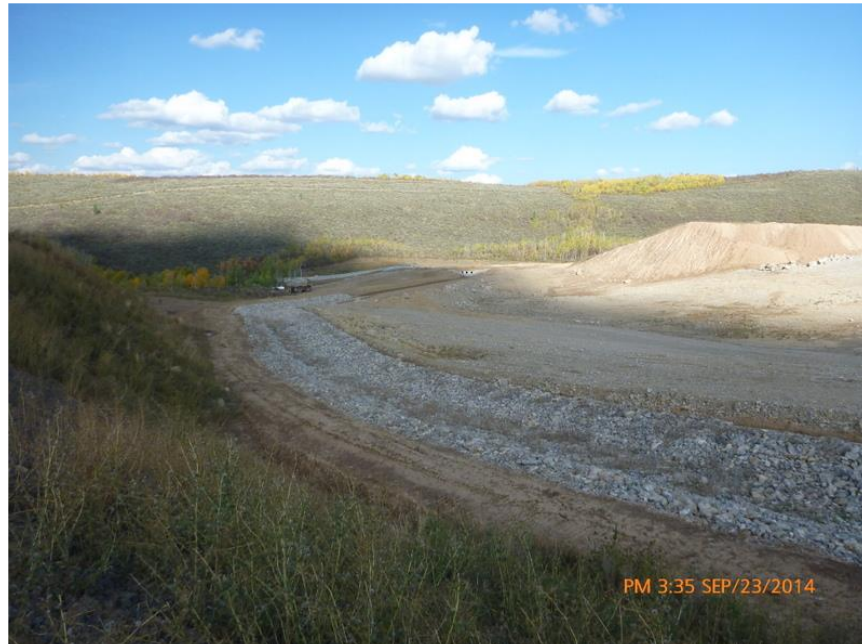
Photo No. 25 (P1000744)

Facing East Southeast – this is the lower end of the haul road stormwater channel (see Photos 23-24) near point of discharge into EP1 (no standing water in EP1 at the time of this inspection).

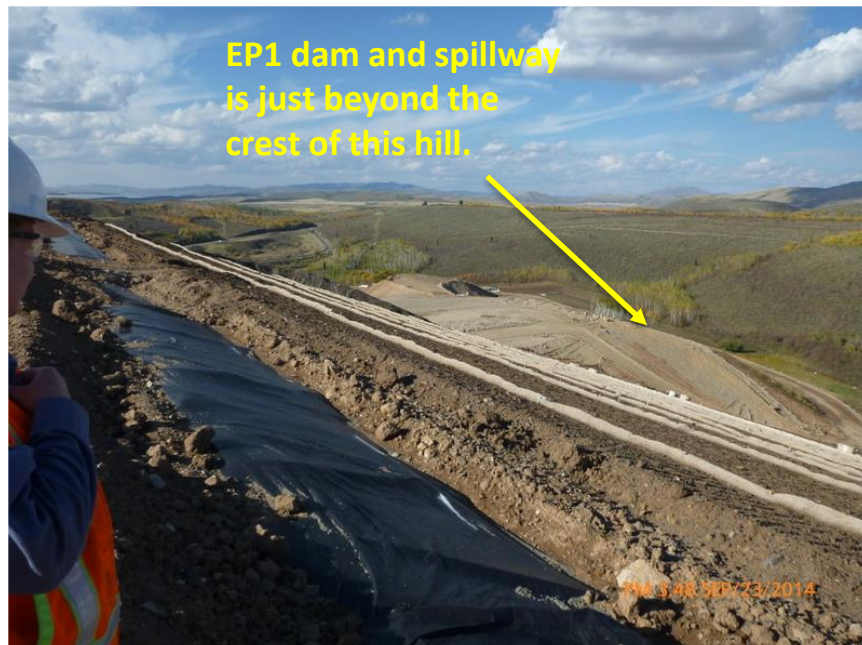
Photo No. 26 (P1000746)

Facing northeast – looking down from near the top of the EOP into the East Ponds drainage. Liners and wattles are used to prevent infiltration and erosion.

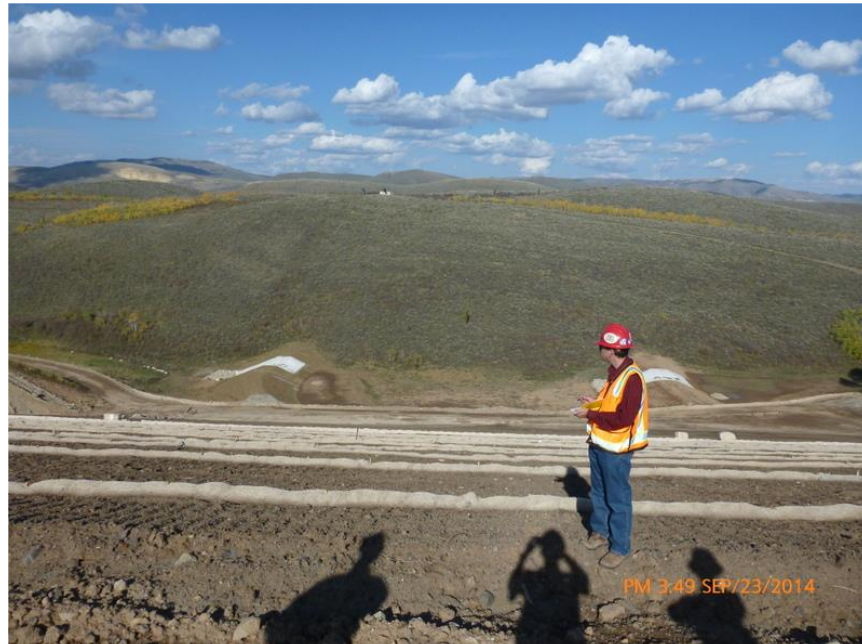
Photo No. 27 (P1000748)
Facing east – view from near the top of the EOP; EP2 and EP3 dam and spillway is visible in the drainage below.

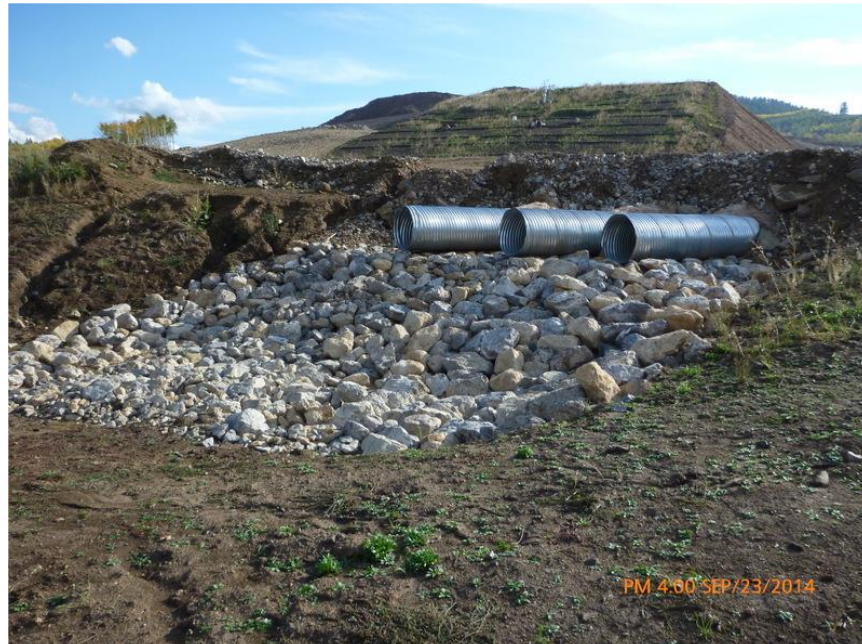
Photo No. 29 (P1000754)
Facing southeast – the rock-lined haul road stormwater channel noted in Photos 23-25 discharge into EP1 at this location above the dam.

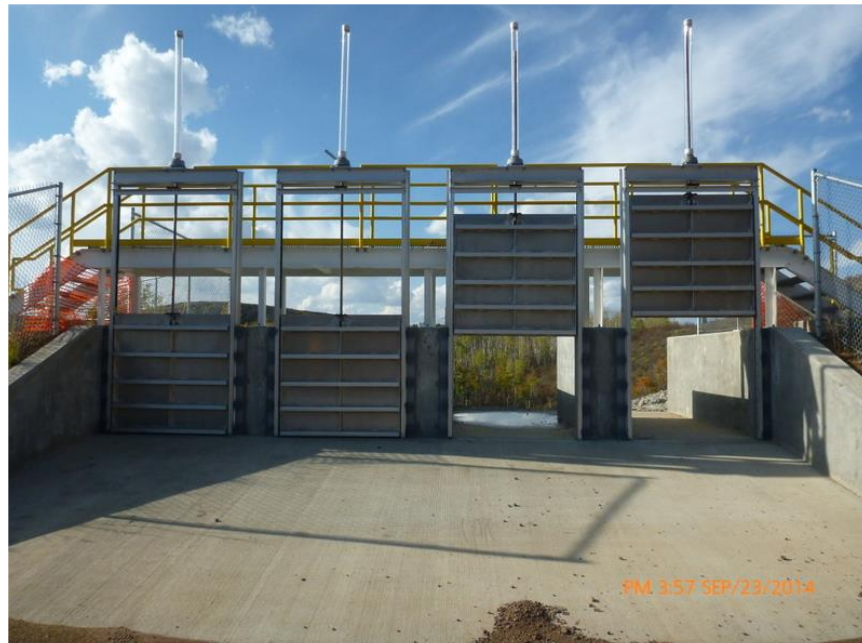
Photo No. 30 (P1000752)
Facing north – These are the headgates at the top of the EP1 spillway. Clean water (water that meets the IWQSS) is discharged via either of the 2 gates on the right-hand side. Water that does not meet the IWQSS is discharged to CP2 via one of the two gates on the left.

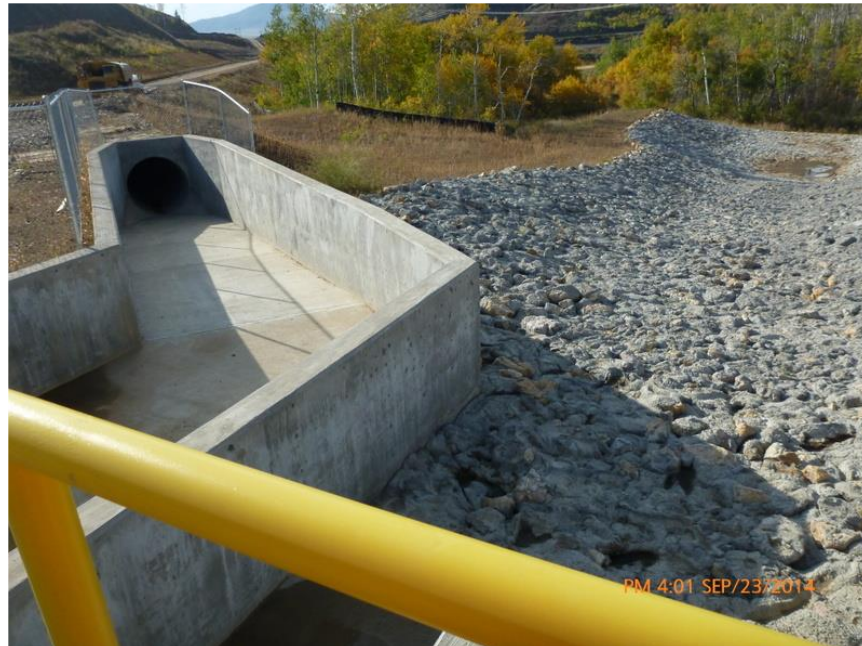
Photo No. 31 (P1000756)

Facing northwest – from the top of spillway it is easy to see the two directions for stormwater discharge from EP1; “clean” water is discharged into the rock-lined channel on the right, into Fish Pond and Wetland K, en route to CP1; the concrete channel conveys “dirty” water to large culvert leading directly to CP2.

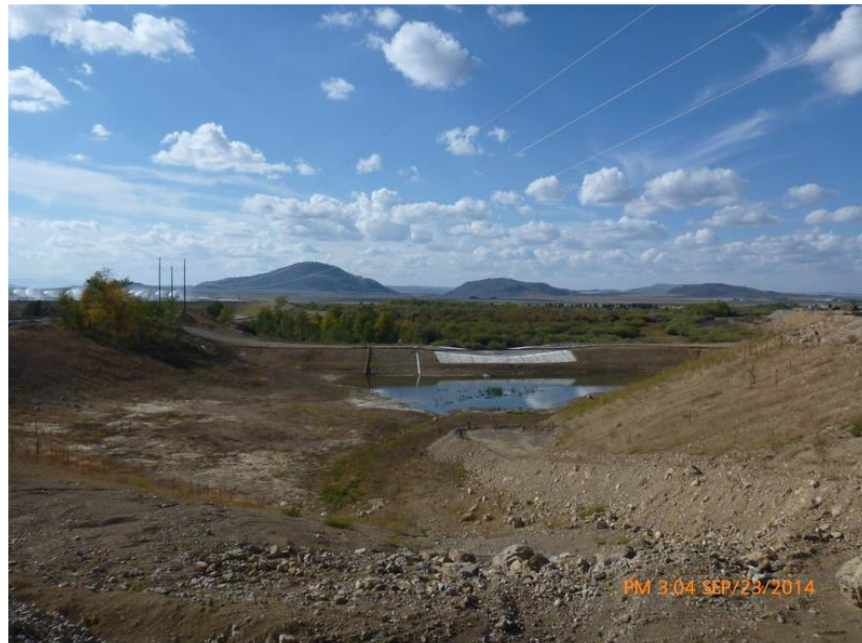
Photo No. 32 (P1000735)

Facing west – CP1 and the spillway to Wetland X; structural failure (since repaired) during the first significant report of stormwater to the pond in March of 2013 led to the discharge of some sediment to Wetland X.

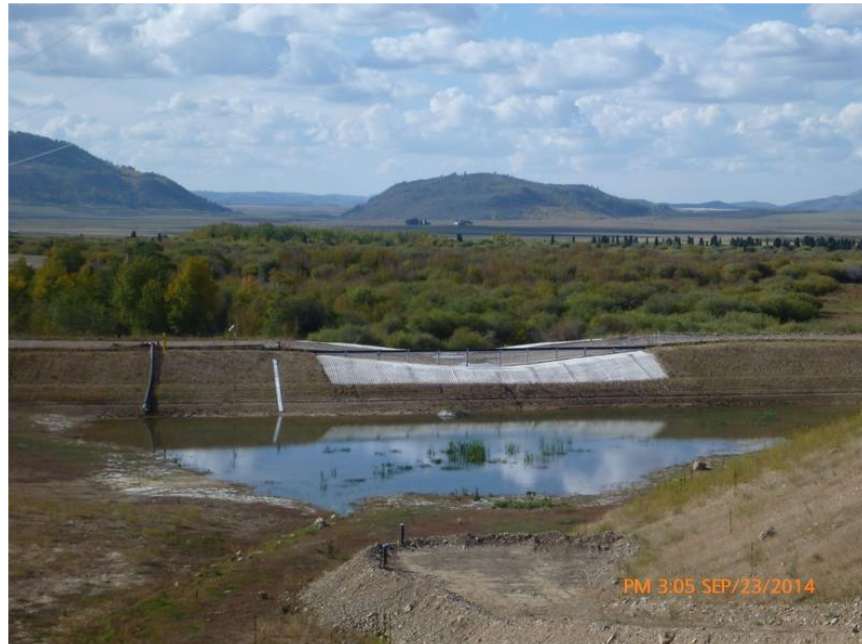
Photo No. 33 (P1000736)
Facing west – close-up view of CP1 and the spillway to Wetland X.

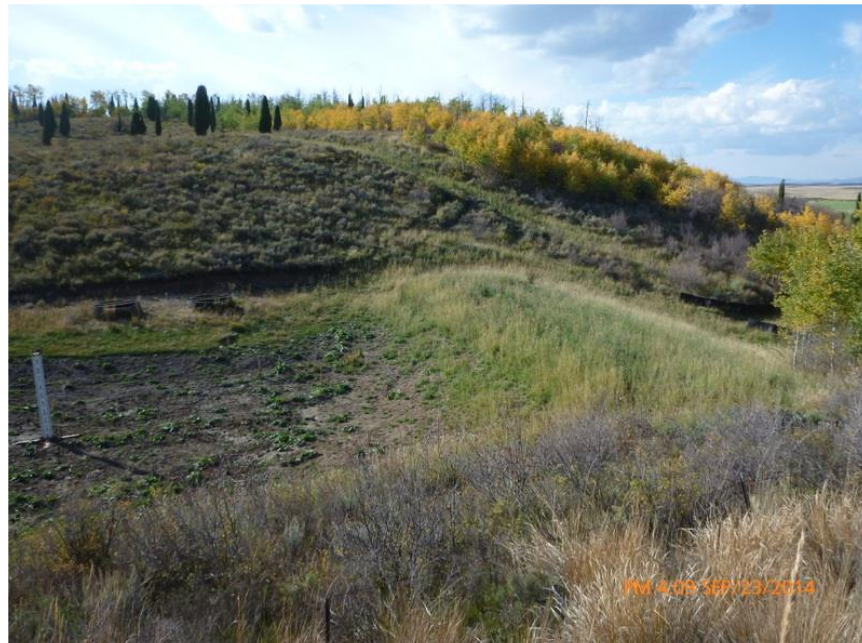
Photo No. 34 (P1000757)
Facing west – stormwater collection pond in “beaver pond” area on the east side of the North Pit. According to the BFB staff, stormwater runoff entering this pond would not come into contact with any disturbed soil.
